## Melvin Price Locks and Dam UMR Mile 201 Auxiliary Miter Gate Failure Weekly Status Report 10 February 2005

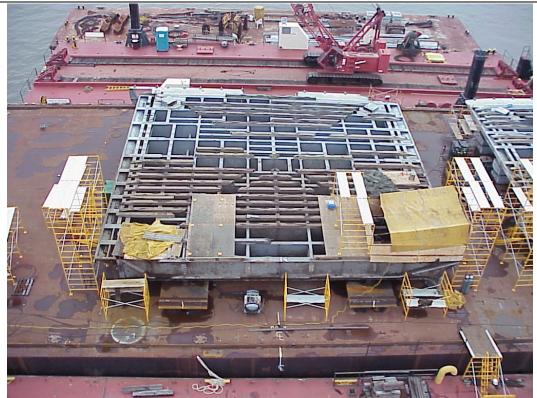
Missouri-side Gate Leaf on repair barge at District Service Base - 8 March 2005 Corps of Engineers' Crane Barge FISHER and Deck-Cargo Barge 51 (at top)

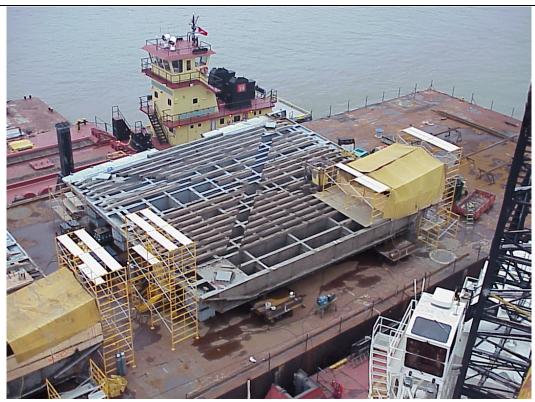
Illinois-side Gate Leaf on repair barge at District Service Base - 8 March 2005

Corps' Towboat GRAND TOWER (at top); Derrickboat SEWELL's cab & boom visible (at right)
